Assessment of Selected Riparian Systems of the Ross and Black River Basins and Selected Other Drainage within the Townsville / Thuringowa Region Stage 2

Report prepared for Creek to Coral

January 2008

CLIENT: CREEK TO CORAL
PROJECT: RIPARIAN ASSESSMENT OF THE ROSS AND BLACK RIVER BASINS
REPORT: RIPARIAN ASSESSMENT
REFERENCE: C2C RIP

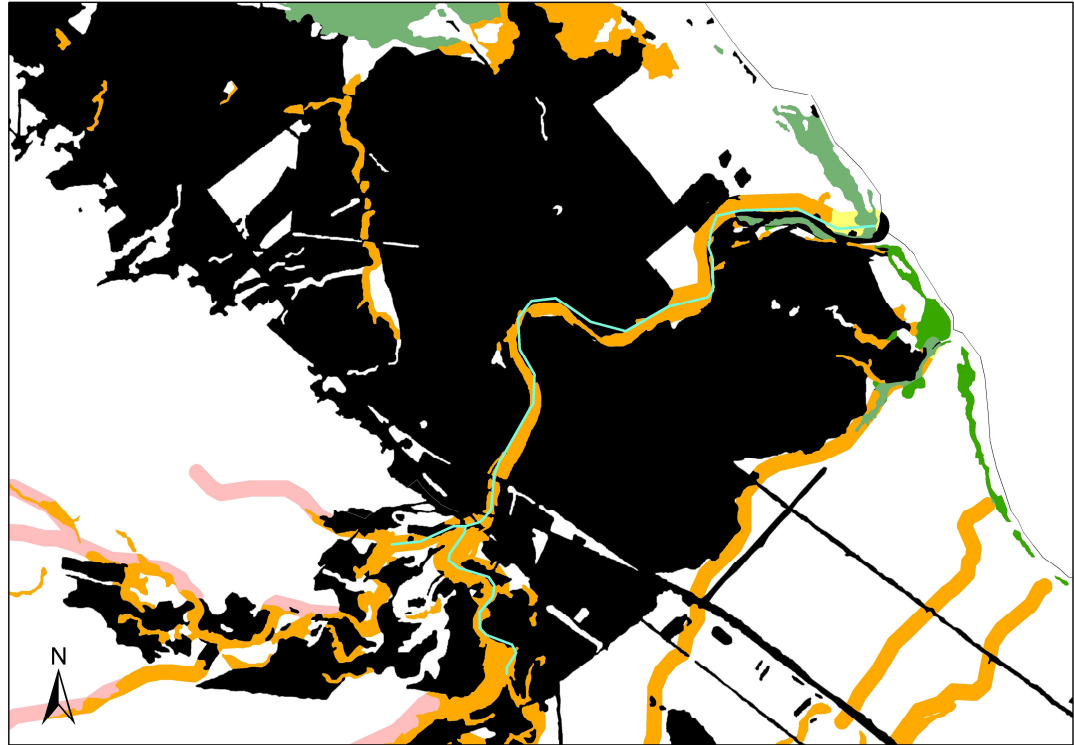
Figure 7: Riparian Systems of the Lower Crystal Creek Catchment.

GREEN	Estuarine/ mangrove systems.
YELLOW	Sand dune wetlands and associated riparian zones.
ORANGE	Vegetation associated with creek lines/river systems, wetlands, and associated riparian vegetation on alluvial plains.
PINK	Vegetation associated with creek lines/river systems, wetlands, and associated riparian vegetation on granitic rock.
BLACK	Areas of non-remnant vegetation.
BLUE	The creek or river system under analysis.

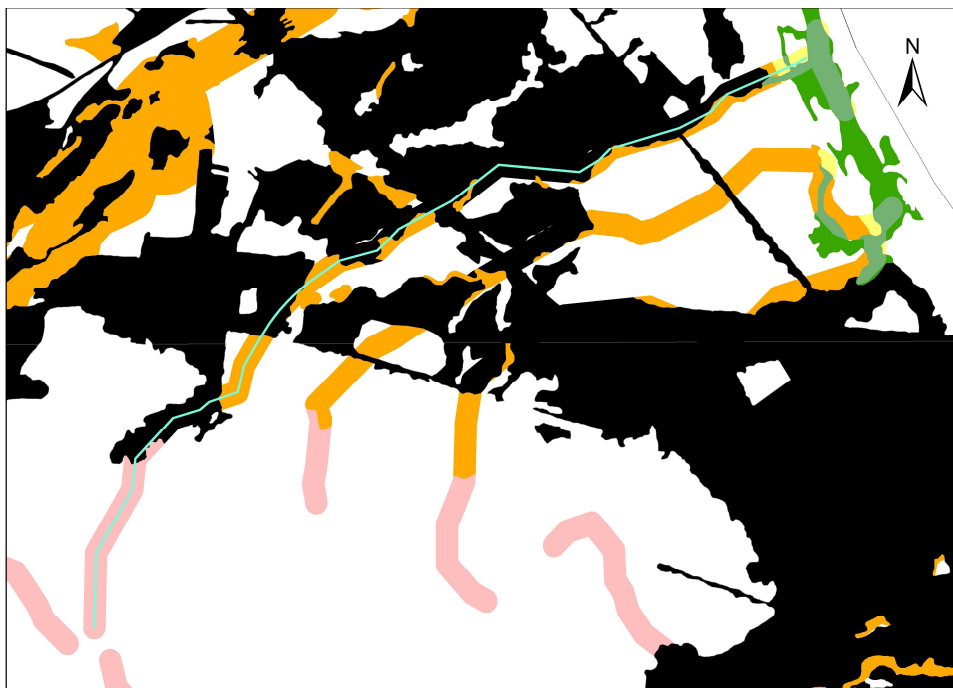
Figure 21: Riparian Systems of Scrubby Creek

GREEN	Estuarine/ mangrove systems.
YELLOW	Sand dune wetlands and associated riparian zones.
ORANGE	Vegetation associated with creek lines/river systems, wetlands, and associated riparian vegetation on alluvial plains.
PINK	Vegetation associated with creek lines/river systems, wetlands, and associated riparian vegetation on granitic rock.
BLACK	Areas of non-remnant vegetation.
BLUE	The creek or river system under analysis.

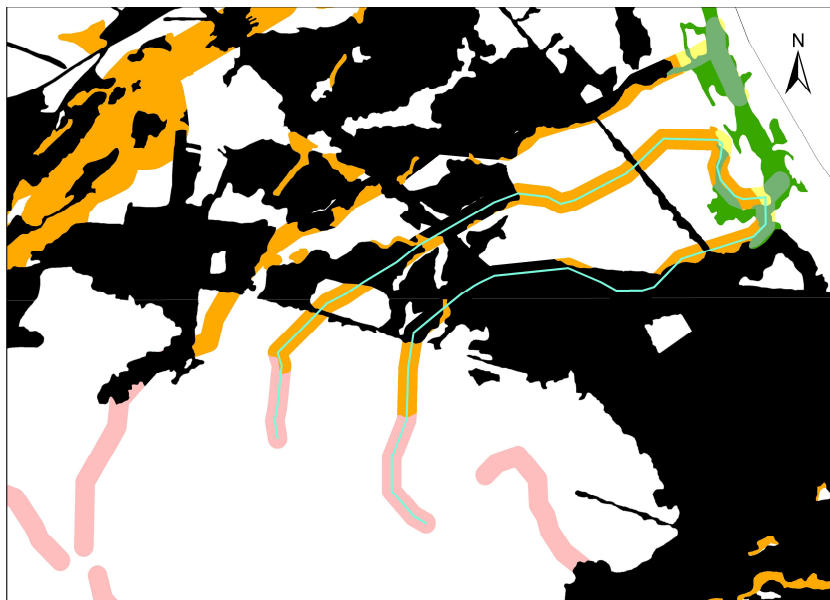
Figure 23: Riparian Systems of Creek 3

GREEN	Estuarine/ mangrove systems.
YELLOW	Sand dune wetlands and associated riparian zones.
ORANGE	Vegetation associated with creek lines/river systems, wetlands, and associated riparian vegetation on alluvial plains.
PINK	Vegetation associated with creek lines/river systems, wetlands, and associated riparian vegetation on granitic rock.
BLACK	Areas of non-remnant vegetation.
BLUE	The creek or river system under analysis.

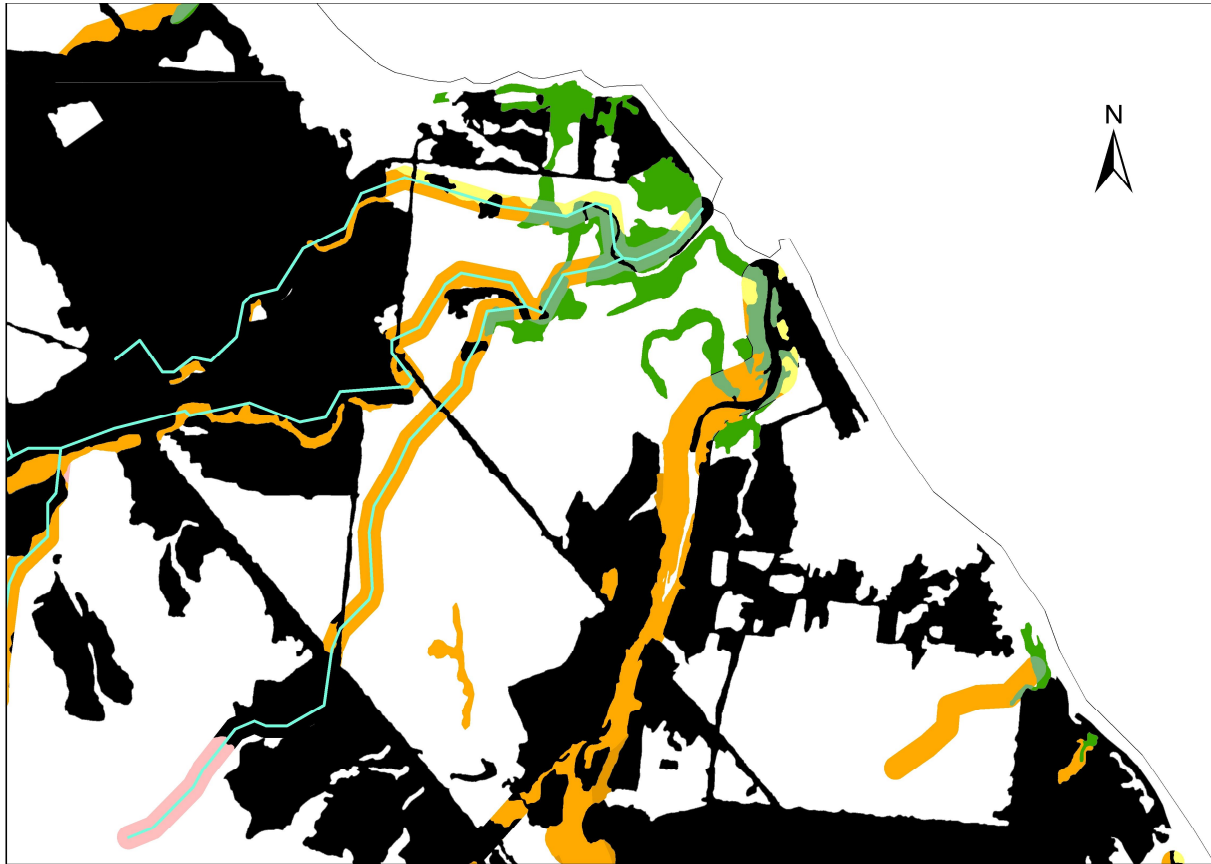
Figure 27: Riparian Systems of Hencamp Creek, Lower Reaches

GREEN	Estuarine/ mangrove systems.
YELLOW	Sand dune wetlands and associated riparian zones.
ORANGE	Vegetation associated with creek lines/river systems, wetlands, and associated riparian vegetation on alluvial plains.
PINK	Vegetation associated with creek lines/river systems, wetlands, and associated riparian vegetation on granitic rock.
BLACK	Areas of non-remnant vegetation.
BLUE	The creek or river system under analysis.

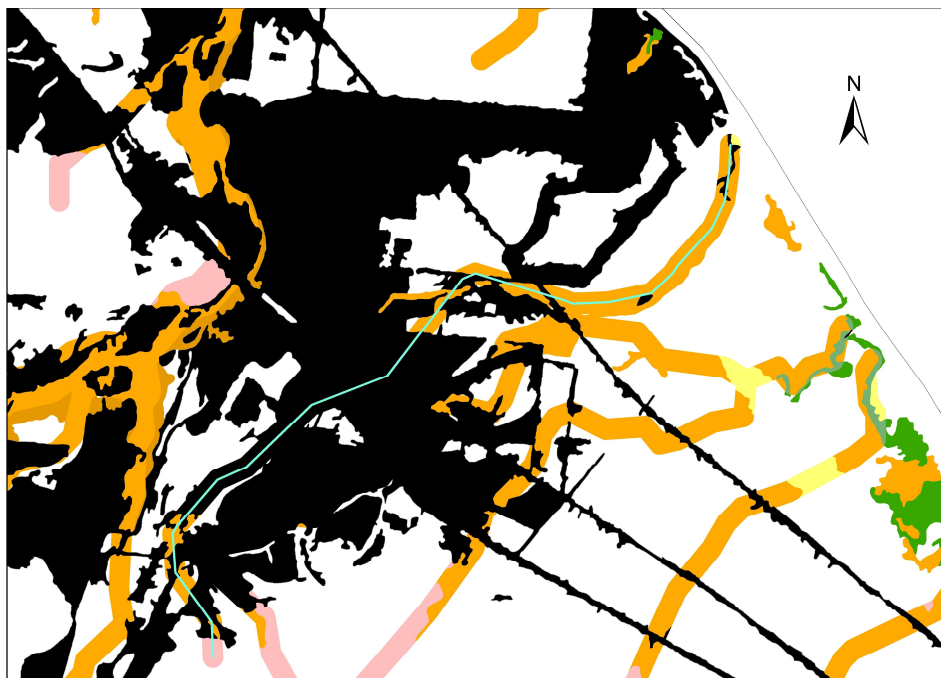
Figure 33: Riparian Systems of Creek 4

GREEN	Estuarine/ mangrove systems.
YELLOW	Sand dune wetlands and associated riparian zones.
ORANGE	Vegetation associated with creek lines/river systems, wetlands, and associated riparian vegetation on alluvial plains.
PINK	Vegetation associated with creek lines/river systems, wetlands, and associated riparian vegetation on granitic rock.
BLACK	Areas of non-remnant vegetation.
BLUE	The creek or river system under analysis.

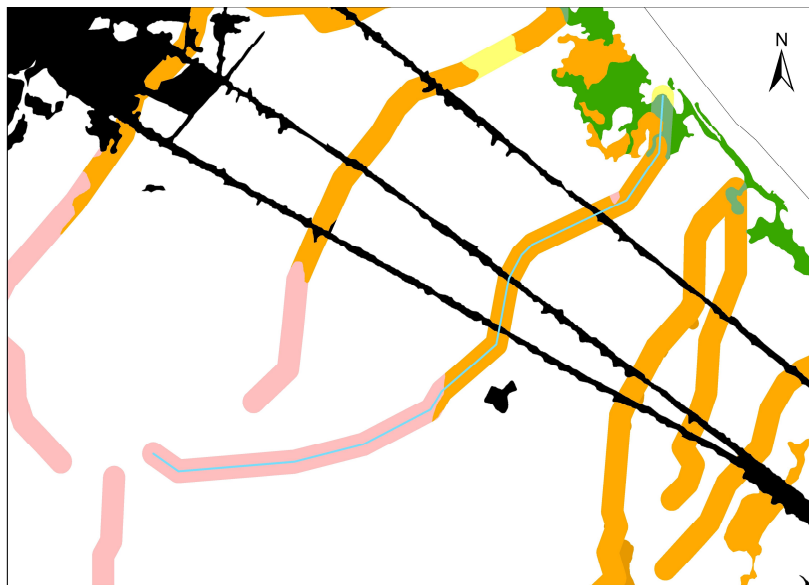
Figure 39: Riparian Systems of Baar Creek

GREEN	Estuarine/ mangrove systems.
YELLOW	Sand dune wetlands and associated riparian zones.
ORANGE	Vegetation associated with creek lines/river systems, wetlands, and associated riparian vegetation on alluvial plains.
PINK	Vegetation associated with creek lines/river systems, wetlands, and associated riparian vegetation on granitic rock.
BLACK	Areas of non-remnant vegetation.
BLUE	The creek or river system under analysis.

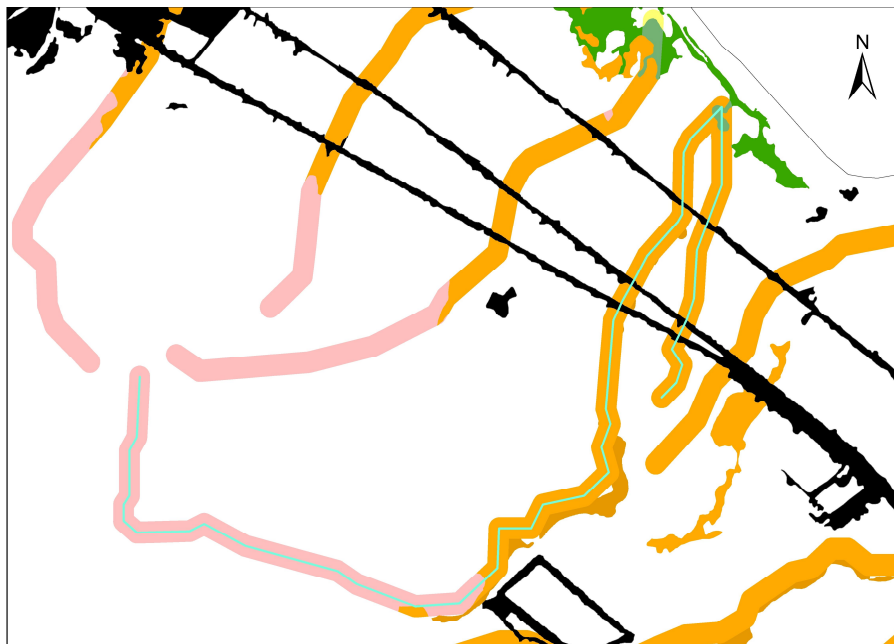
Figure 41: Riparian Systems of Station Creek

GREEN	Estuarine/ mangrove systems.
YELLOW	Sand dune wetlands and associated riparian zones.
ORANGE	Vegetation associated with creek lines/river systems, wetlands, and associated riparian vegetation on alluvial plains.
PINK	Vegetation associated with creek lines/river systems, wetlands, and associated riparian vegetation on granitic rock.
BLACK	Areas of non-remnant vegetation.
BLUE	The creek or river system under analysis.
